### **OWNER MANUAL**

MOUNTAIN TOP® EVOe ROLL COVER

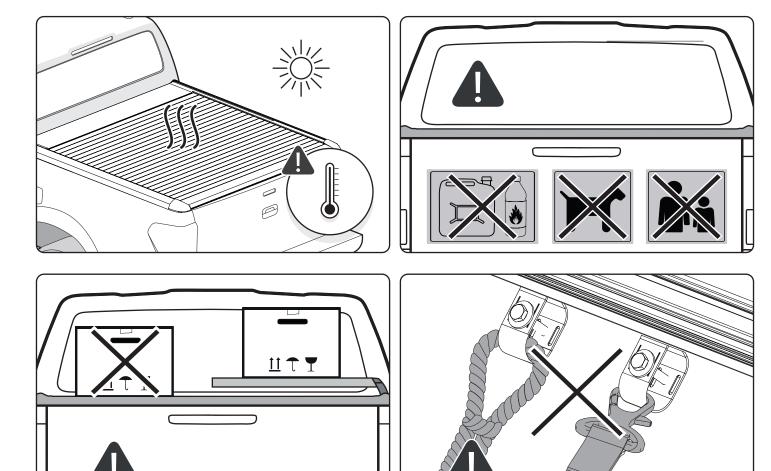
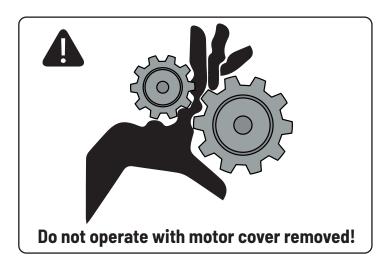
- Temperatures can be very high under the cover when closed.
- We do not recommend washing the EVOe roll cover in a brushless carwash, as the coating may be damaged due to use of chemicals.

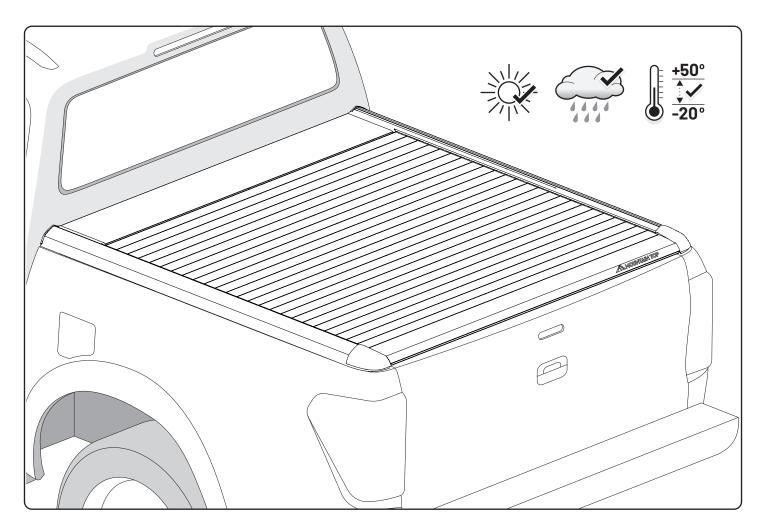
- The EVOe roll cover design is lightweight and not suitable for extreme usage.
- Designed to withstand rain water, some water ingress may occur.
- Dust can enter the compartment through various gaps.
- Due to profiles which relatively quick heats up and cools down according to weather conditions can cause condensation on the inside.
- The EVOe roll cover is not designed for loading although it can support normal snow loads.
- Goods in the bed must be secured during transportation to prevent damage.

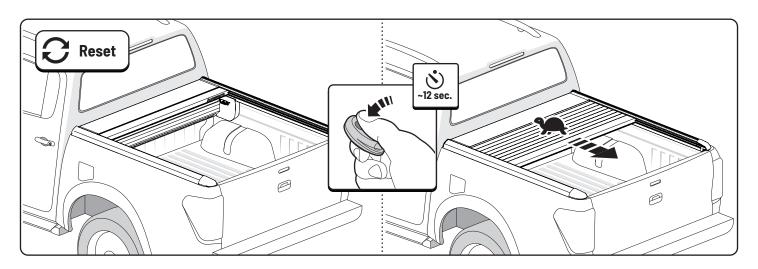
Auto calibration

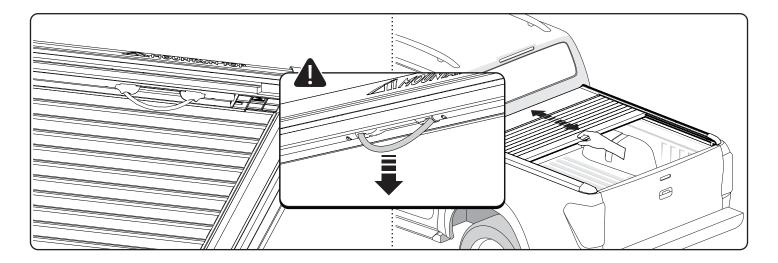
Release - manual operating.

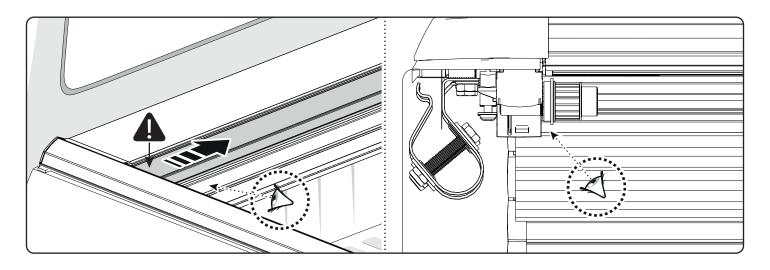
Reconnect after manual operation.

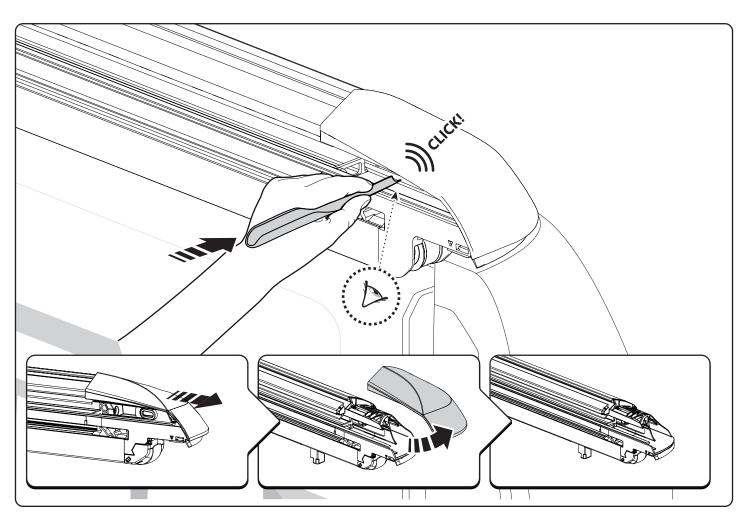
• Use the multi tool to remove the plastic covers on the side profiles.

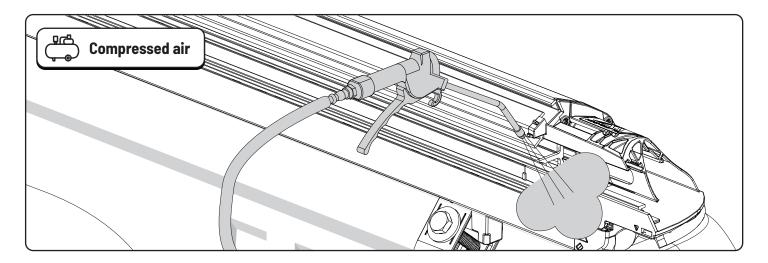
Remove dirt and debris using compressed air.

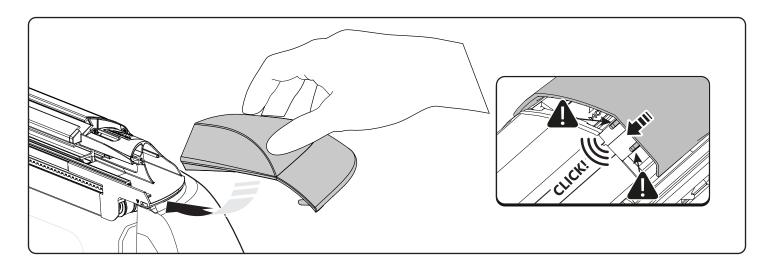
Mount plastic covers.

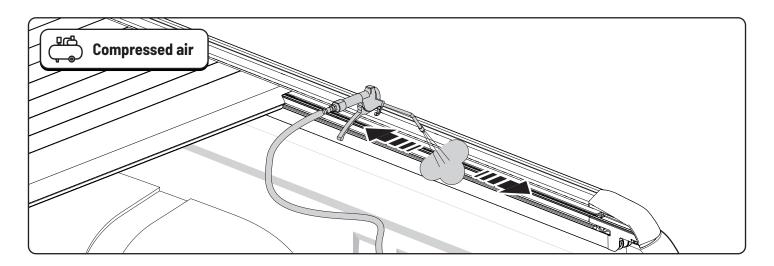
Clean the side profiles.

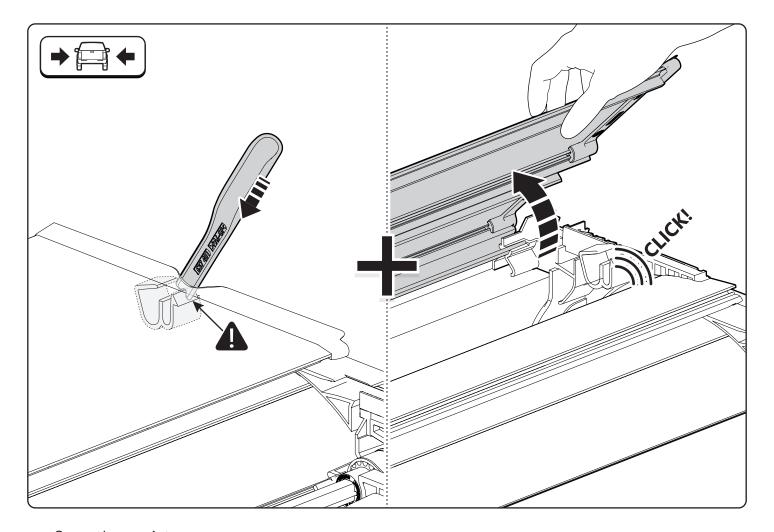
• Open the canister.

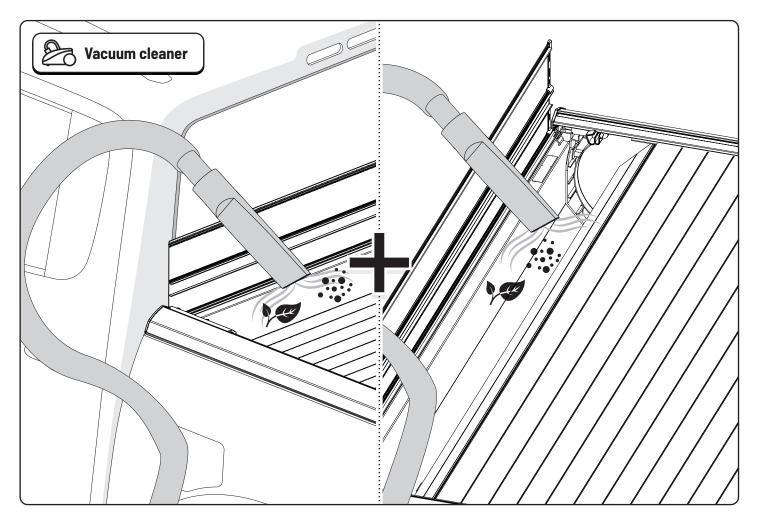
• Clean the canister.

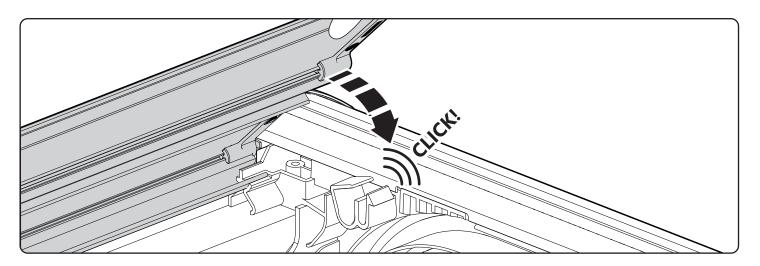
Close the canister.

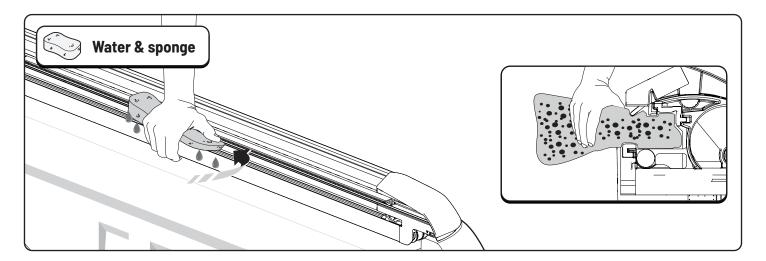
• Clean the drainage channels on the side profiles. Do not use high pressure cleaner.

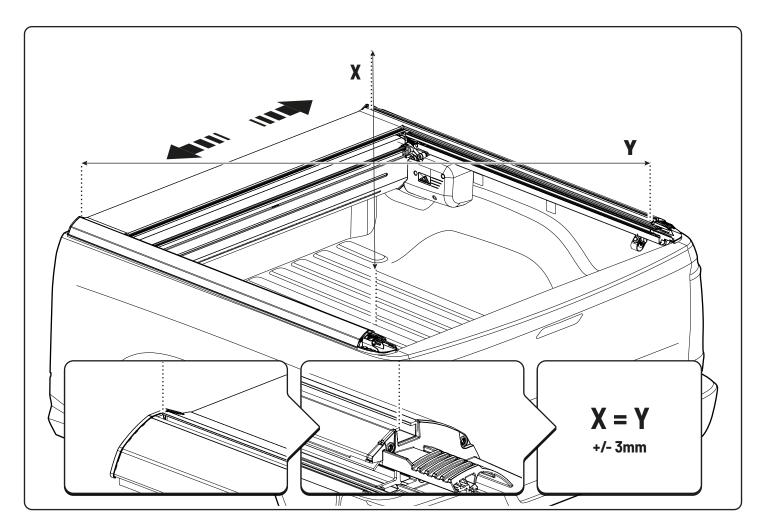
• Ensure the cross measurements are identical.

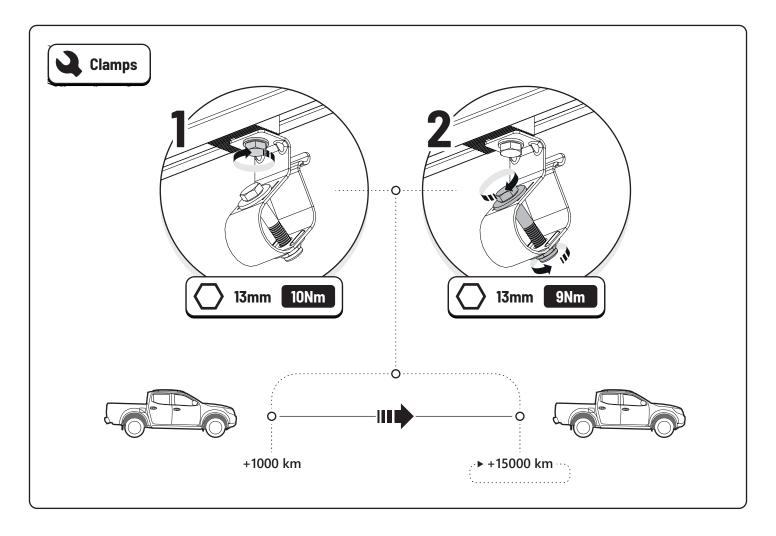
• Re-tighten the clamps after the first 1000 km. And then every 15.000 km

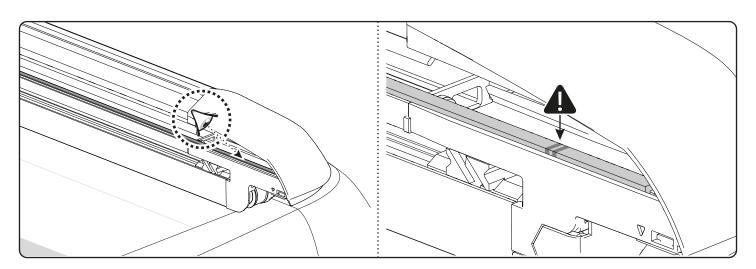
• If abnormal sounds occur during operation of the roll cover, inspect the glide rails for debris or damage. If the glide rails are damaged or worn, then replacement glide rails are needed.

• If operation of the roll cover is not improved after tightening the belt drive, or abnormal sounds persists, refer to section **Check glide rails maintenance** on page 22.

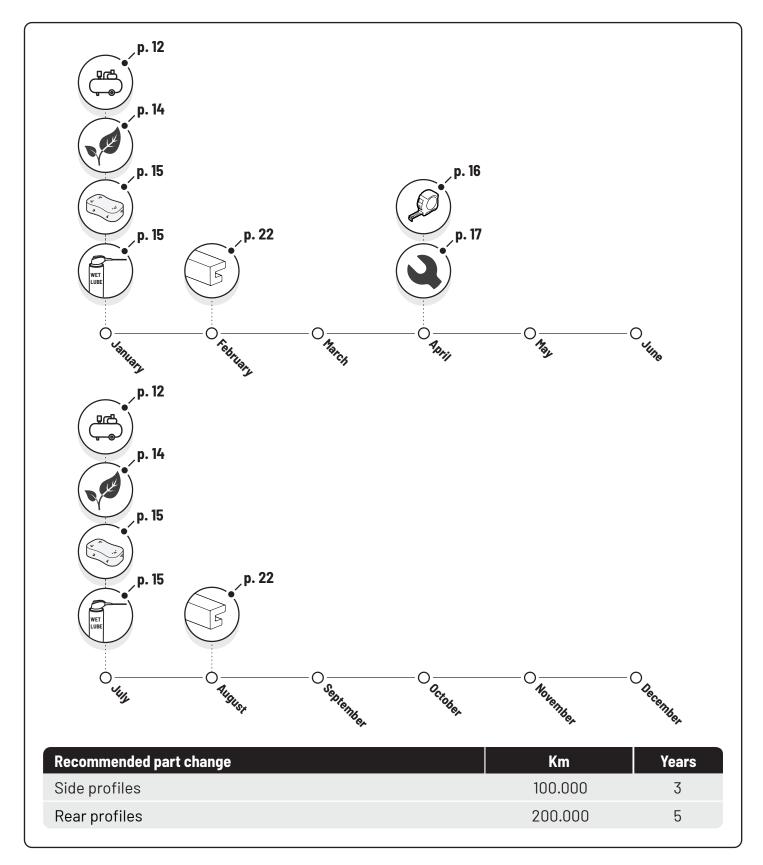
- Maintenance requirements and frequency depend on the actual usage of the roll cover and the environments and elements that it is exposed to.
- Clean and lubricate the cover accordingly to ensure the best possible operation and function.
